## [붙임 1. 측정결과]

## [붙임 2. 측정지점]

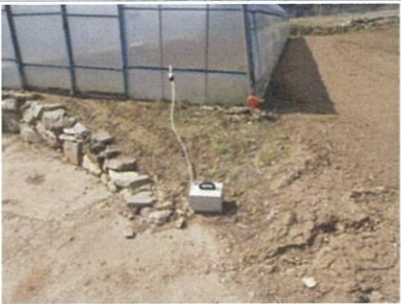
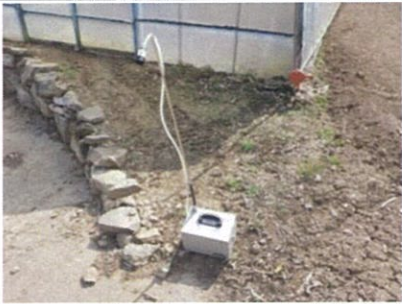
| 측정 지점 | 비산측정 시작 사진 | 비산측정 종료 사진 | 비고 |
|---|---|---|---|
| #A01<br>부지경계선 1 | | | - |

| | 시료번호 | 측정 지점 | 측정 장비<br>(종류/수량) | 유량<br>(ℓ/분) | 측정 일시 | 측정 결과<br>(f/cc) | 검출석면의<br>종류 |
|---|---|---|---|---|---|---|---|
| 측정 결과 | #A01 | 부지경계선 1 | YSP1045S/1 | 11.47 | 2020.04.02 | 0.001 | 백석면 |

| 측정 지점 | 비산측정 시작 사진 | 비산측정 종료 사진 | 비고 |
|---|---|---|---|
| | 측정 시작 시간 : 10:15 | 측정 종료 시간 : 14:15 | |

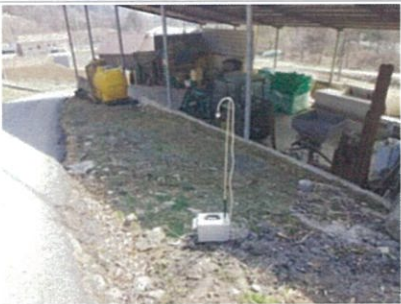
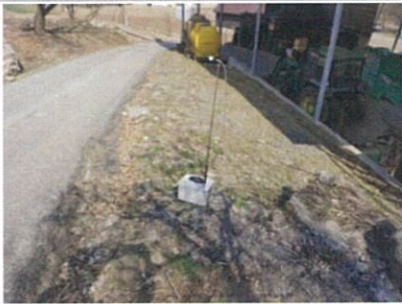
| 측정 지점 | 비산측정 시작 사진 | 비산측정 종료 사진 | 비고 |
|---|---|---|---|
| #A02<br>부지경계선 2 | | | - |

| | 시료번호 | 측정 지점 | 측정 장비<br>(종류/수량) | 유량<br>(ℓ/분) | 측정 일시 | 측정 결과<br>(f/cc) | 검출석면의<br>종류 |
|---|---|---|---|---|---|---|---|
| | #A02 | 부지경계선 2 | YSP1045S/1 | 11.04 | 2020.04.02 | 0.001 | 백석면 |

| 측정 지점 | 비산측정 시작 사진 | 비산측정 종료 사진 | 비고 |
|---|---|---|---|
| | 측정 시작 시간 : 10:16 | 측정 종료 시간 : 14:16 | |

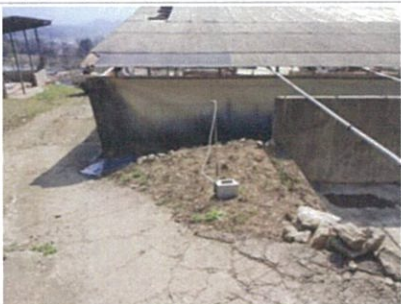
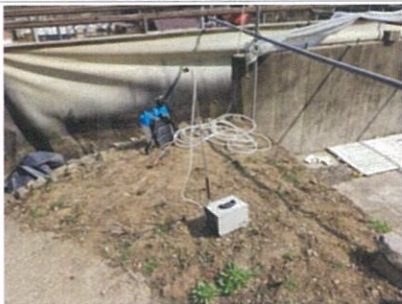
| 측정 지점 | 비산측정 시작 사진 | 비산측정 종료 사진 | 비고 |
|---|---|---|---|
| #A03<br>부지경계선 3 | | | - |

| | 시료번호 | 측정 지점 | 측정 장비<br>(종류/수량) | 유량<br>(ℓ/분) | 측정 일시 | 측정 결과<br>(f/cc) | 검출석면의<br>종류 |
|---|---|---|---|---|---|---|---|
| | #A03 | 부지경계선 3 | YSP1045S/1 | 11.50 | 2020.04.02 | 0.001 | 백석면 |

| 측정 지점 | 비산측정 시작 사진 | 비산측정 종료 사진 | 비고 |
|---|---|---|---|
| | 측정 시작 시간 : 10:18 | 측정 종료 시간 : 14:18 | |

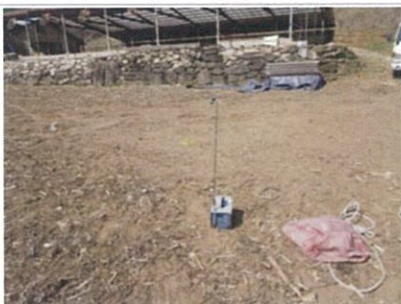
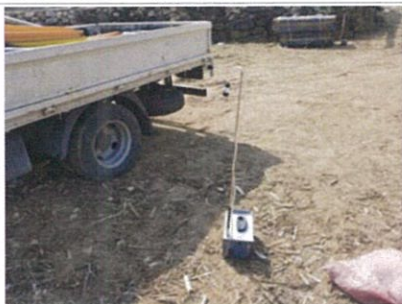
| 측정 지점 | 비산측정 시작 사진 | 비산측정 종료 사진 | 비고 |
|---|---|---|---|
| #A04<br>부지경계선 4 | | | - |

| | 시료번호 | 측정 지점 | 측정 장비<br>(종류/수량) | 유량<br>(ℓ/분) | 측정 일시 | 측정 결과<br>(f/cc) | 검출석면의<br>종류 |
|---|---|---|---|---|---|---|---|
| | #A04 | 부지경계선 4 | YSP1045S/1 | 11.46 | 2020.04.02 | 0.001 | 백석면 |

| 측정 지점 | 비산측정 시작 사진 | 비산측정 종료 사진 | 비고 |
|---|---|---|---|
| | 측정 시작 시간 : 10:19 | 측정 종료 시간 : 14:19 | |

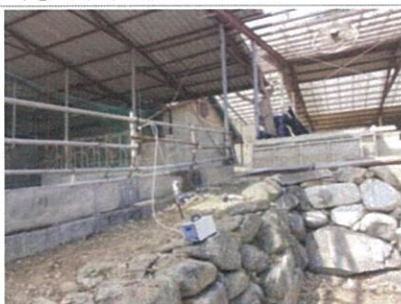
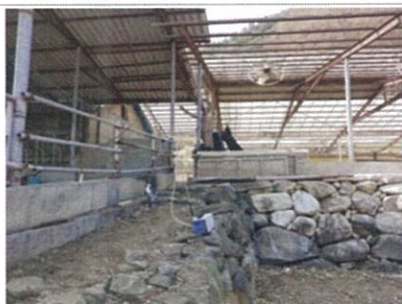
| 측정 지점 | 비산측정 시작 사진 | 비산측정 종료 사진 | 비고 |
|---|---|---|---|
| #A05<br>작업장주변(실외) 1 | | | - |

| | 시료번호 | 측정 지점 | 측정 장비<br>(종류/수량) | 유량<br>(ℓ/분) | 측정 일시 | 측정 결과<br>(f/cc) | 검출석면의<br>종류 |
|---|---|---|---|---|---|---|---|
| | #A05 | 작업장주변(실외) 1 | YSP1045S/1 | 11.25 | 2020.04.02 | 0.001 | 백석면 |

| 측정 지점 | 비산측정 시작 사진 | 비산측정 종료 사진 | 비고 |
|---|---|---|---|
| | 측정 시작 시간 : 10:23 | 측정 종료 시간 : 12:23 | |

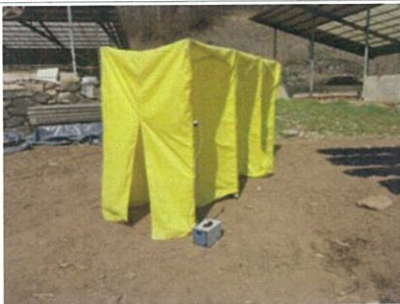
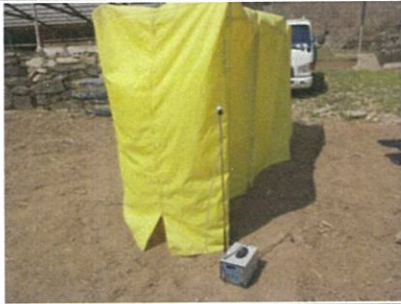
| 측정 지점 | 비산측정 시작 사진 | 비산측정 종료 사진 | 비고 |
|---|---|---|---|
| #A06<br>위생설비입구 1 | | | - |

| | 시료번호 | 측정 지점 | 측정 장비<br>(종류/수량) | 유량<br>(ℓ/분) | 측정 일시 | 측정 결과<br>(f/cc) | 검출석면의<br>종류 |
|---|---|---|---|---|---|---|---|
| | #A06 | 위성설비입구 1 | YSP1045S/1 | 11.65 | 2020.04.02 | 0.001 | 백석면 |

| 측정 지점 | 비산측정 시작 사진 | 비산측정 종료 사진 | 비고 |
|---|---|---|---|
| | 측정 시작 시간 : 10:34 | 측정 종료 시간 : 11:14 | |

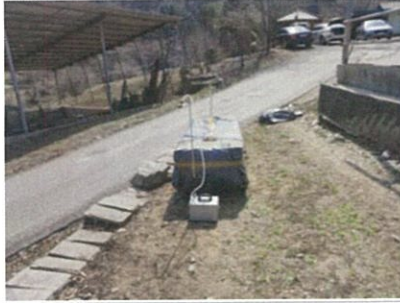
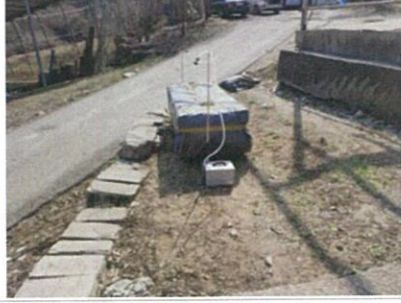
| 측정 지점 | 비산측정 시작 사진 | 비산측정 종료 사진 | 비고 |
|---|---|---|---|
| #A07<br>폐기물보관지점 1 | | | - |

| | 시료번호 | 측정 지점 | 측정 장비<br>(종류/수량) | 유량<br>(ℓ/분) | 측정 일시 | 측정 결과<br>(f/cc) | 검출석면의<br>종류 |
|---|---|---|---|---|---|---|---|
| | #A07 | 폐기물보관지점 1 | YSP1045S/1 | 11.51 | 2020.04.02 | 0.001 | 백석면 |

| 측정 지점 | 비산측정 시작 사진 | 비산측정 종료 사진 | 비고 |
|---|---|---|---|
| | 측정 시작 시간 : 13:38 | 측정 종료 시간 : 14:18 | |

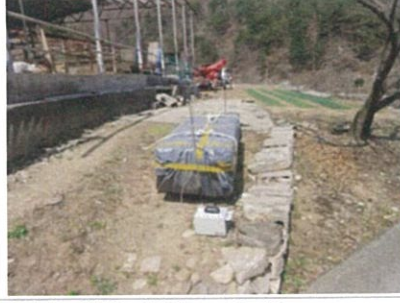
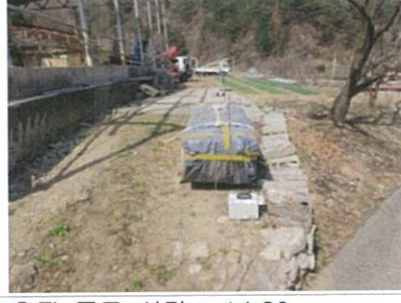
| 측정 지점 | 비산측정 시작 사진 | 비산측정 종료 사진 | 비고 |
|---|---|---|---|
| #A08<br>폐기물보관지점 2 | | | - |

| | 시료번호 | 측정 지점 | 측정 장비<br>(종류/수량) | 유량<br>(ℓ/분) | 측정 일시 | 측정 결과<br>(f/cc) | 검출석면의<br>종류 |
|---|---|---|---|---|---|---|---|
| | #A08 | 폐기물보관지점 2 | YSP1045S/1 | 11.21 | 2020.04.02 | 0.001 | 백석면 |

| 측정 지점 | 비산측정 시작 사진 | 비산측정 종료 사진 | 비고 |
|---|---|---|---|
| | 측정 시작 시간 : 13:40 | 측정 종료 시간 : 14:20 | |

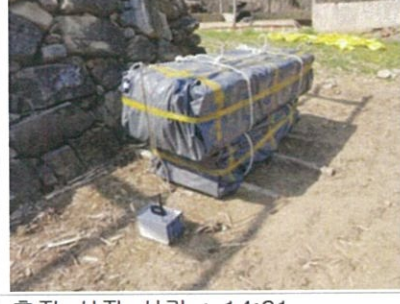
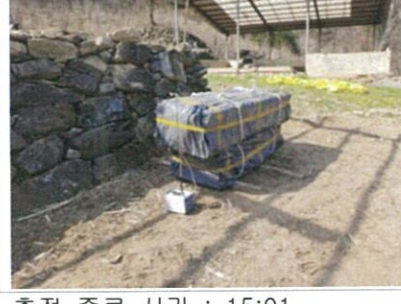
| 측정 지점 | 비산측정 시작 사진 | 비산측정 종료 사진 | 비고 |
|---|---|---|---|
| #A09<br>폐기물보관지점 3 | | | - |

| | 시료번호 | 측정 지점 | 측정 장비<br>(종류/수량) | 유량<br>(ℓ/분) | 측정 일시 | 측정 결과<br>(f/cc) | 검출석면의<br>종류 |
|---|---|---|---|---|---|---|---|
| | #A09 | 폐기물보관지점 3 | YSP1045S/1 | 11.72 | 2020.04.02 | 0.001 | 백석면 |

| 측정 지점 | 비산측정 시작 사진 | 비산측정 종료 사진 | 비고 |
|---|---|---|---|
| | 측정 시작 시간 : 14:21 | 측정 종료 시간 : 15:01 | |

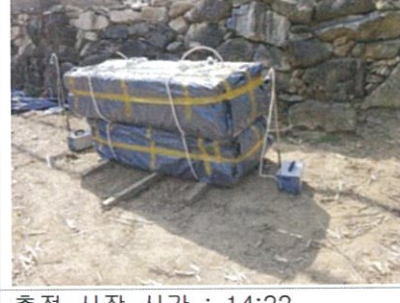
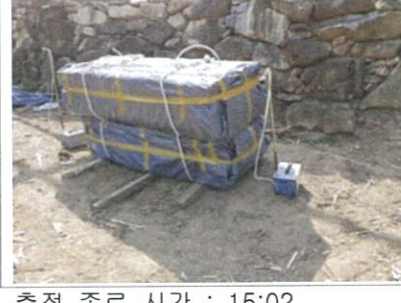
| 측정 지점 | 비산측정 시작 사진 | 비산측정 종료 사진 | 비고 |
|---|---|---|---|
| #A10<br>폐기물보관지점 4 | | | - |

| | 시료번호 | 측정 지점 | 측정 장비<br>(종류/수량) | 유량<br>(ℓ/분) | 측정 일시 | 측정 결과<br>(f/cc) | 검출석면의<br>종류 |
|---|---|---|---|---|---|---|---|
| | #A10 | 폐기물보관지점 4 | YSP1045S/1 | 11.30 | 2020.04.02 | 0.001 | 백석면 |

| 측정 지점 | 비산측정 시작 사진 | 비산측정 종료 사진 | 비고 |
|---|---|---|---|
| | 측정 시작 시간 : 14:22 | 측정 종료 시간 : 15:02 | |
